# ACCIDENT REVIEW: STORM RESTORATION

Sometimes post-storm restoration efforts can be as dangerous as the storm itself. Here is a case study describing a fatality that occurred when a lineman was doing such work.

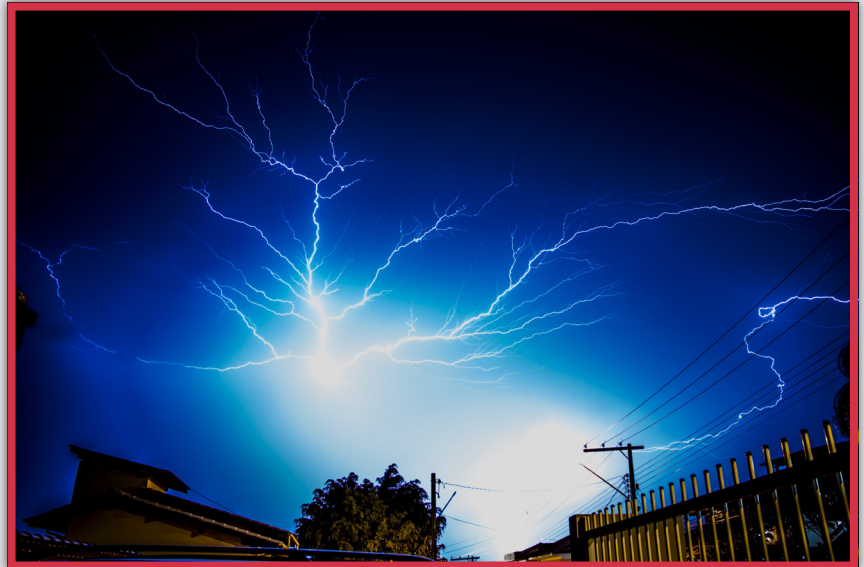
In this particular instance, a power company chief lineman was electrocuted after making contact with 4,200 volts from an energized power line. The incident occurred when the victim was preparing to splice a length of copper wire to a power line that had broken during a storm.

Although the line was thought to have been de-energized, feedback energy was present in the line from an energized transformer bank. The lineman was electrocuted after taking hold of the hanging line to begin the repair

- Employers and employees must insure that personal protective equipment such as insulating gloves are consistently used.
- All electrical lines and conductors should be tested to ensure that they are de-energized prior to working on or near them.
- Employers should ensure that established company safety procedures are followed at all times.
